PROGRAMME OF DIRECT SUPPORT TO INDUSTRY IN DEVELOPING COUNTRIES:  
FACT-FINDING AND PROJECT IDENTIFICATION MISSIONS

Technical report: The cement industry in Nicaragua\*

Prepared for the Government of Nicaragua  
by the United Nations Industrial Development Organization

Based on the work of B. Bülow Andersen, mechanical engineer  
and A. Nérholm, process engineer

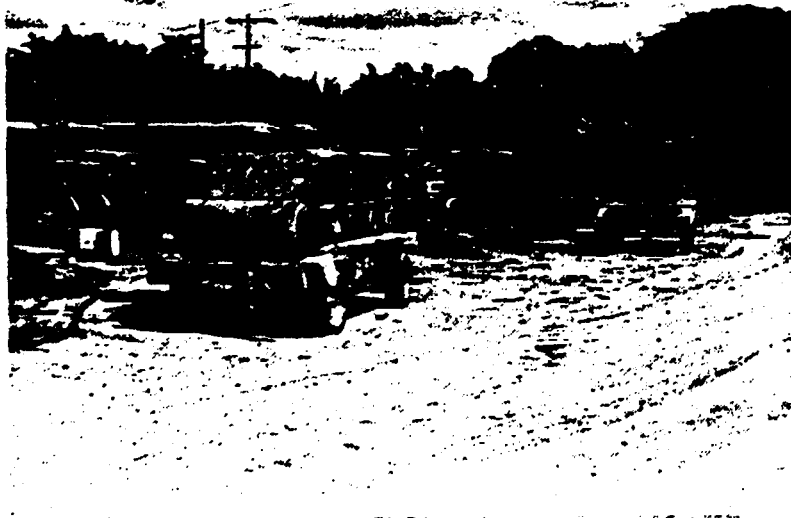
Garage area. Mainly scrapped equipment owing to lack of spare parts.
